INDIAN ISLAND MOORINGS

PROJECT COMPLETION REPORT

FPO-1-79(9)

OCTOBER 1979

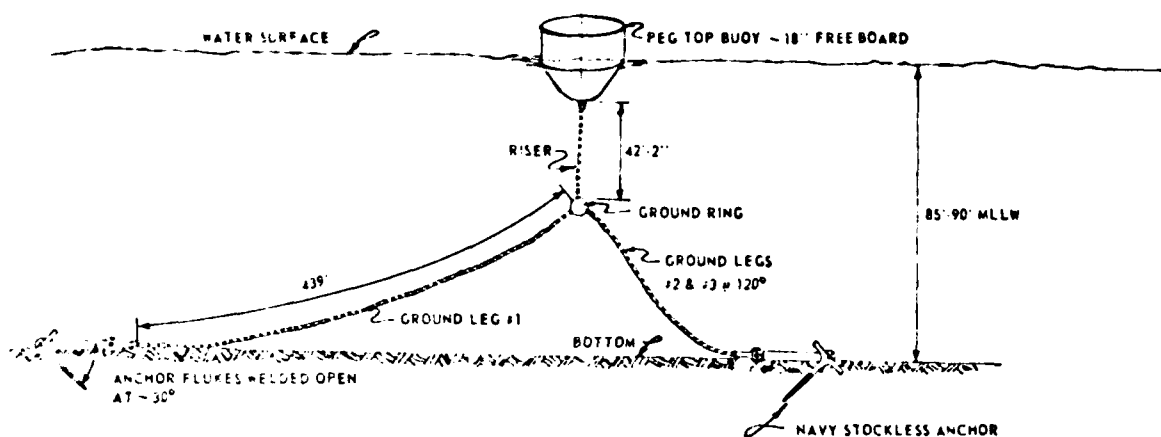
FIGURE 5

FINAL INSTALLATION WITH SHORTENED
RISER AND GROUND RING RAISED
